DEPARTMENT OF THE ARMY  
UNITED STATES ARMY AVIATION TEST BOARD  
Fort Rucker, Alabama 36360

SUBJECT: Letter Report, (6) Product-Improvement Test of Component  
TBO Extension, UH-1( ) Helicopter, RDT&E Project No.  
(16) USATECOM Project No 4-5-0101-03

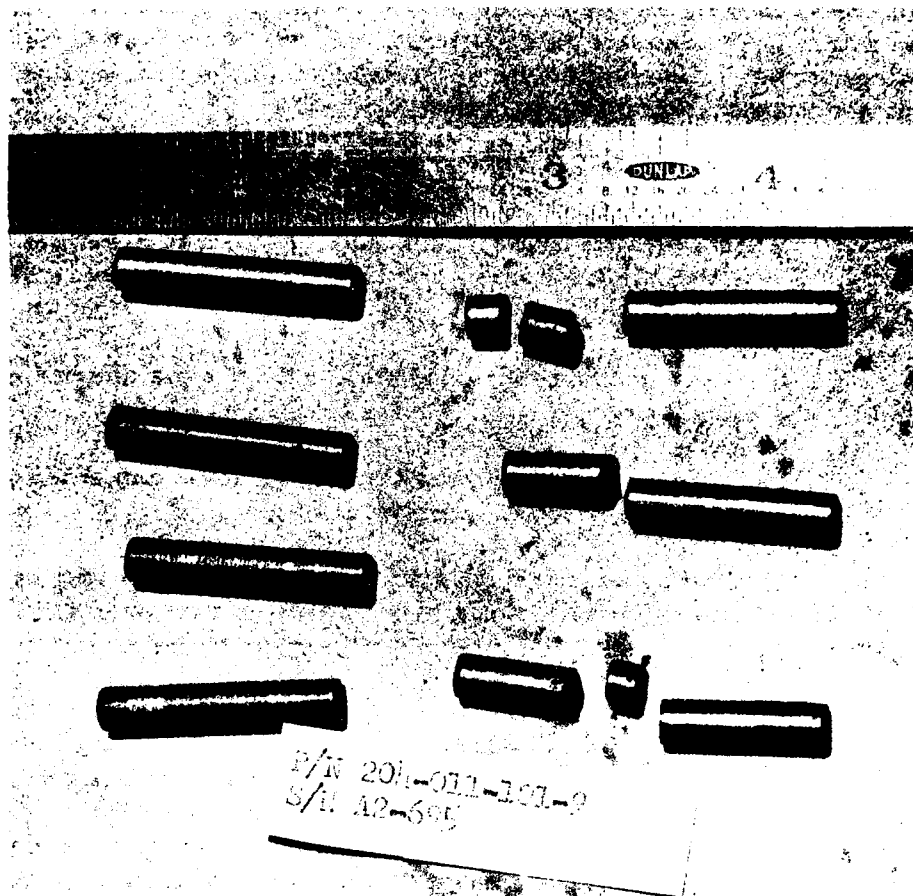
b. S/N A2-695. This hub had operated 1100.6 hours in RVN prior to receipt. Inspection revealed that the hub was unserviceable for testing because of damaged trunnion bearings. One of the bearings had three rollers missing and one had five missing. At disassembly, several of the cracked rollers came loose from their pockets (figure 1). The trunnion bearing inner race was badly galled (figure 2). The bearing cage was not pressed out for inspection of the outer race.

Figure 1. Dislodged and broken roller bearings (main-rotor hub, S/N A2-695, 1100.6 operating hours).

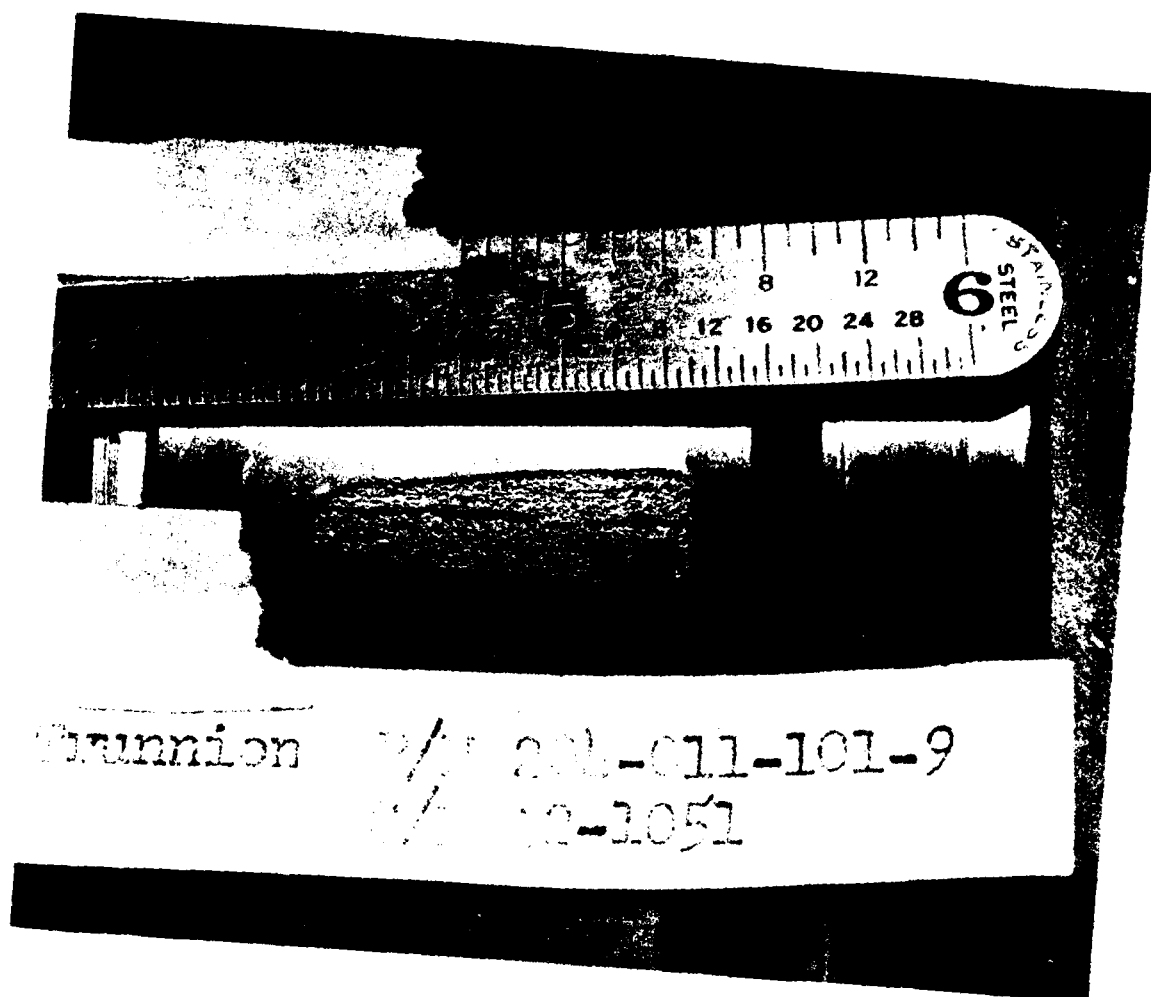
c. S/N A2-1051. This hub had operated 1148.3 hours in RVN. Inspection revealed the hub to be unserviceable because of trunnion bearing race deterioration. The inner race on one trunnion spindle had a galled mark 0.875 inch longitudinally by 0.250 inch circumferentially (figure 3). No deterioration was evident in the roller bearings.

Figure 3. Galling of trunnion bearing inner race.  
(Main-rotor hub, S/N A2-1051, 1148.3 operating  
hours.)

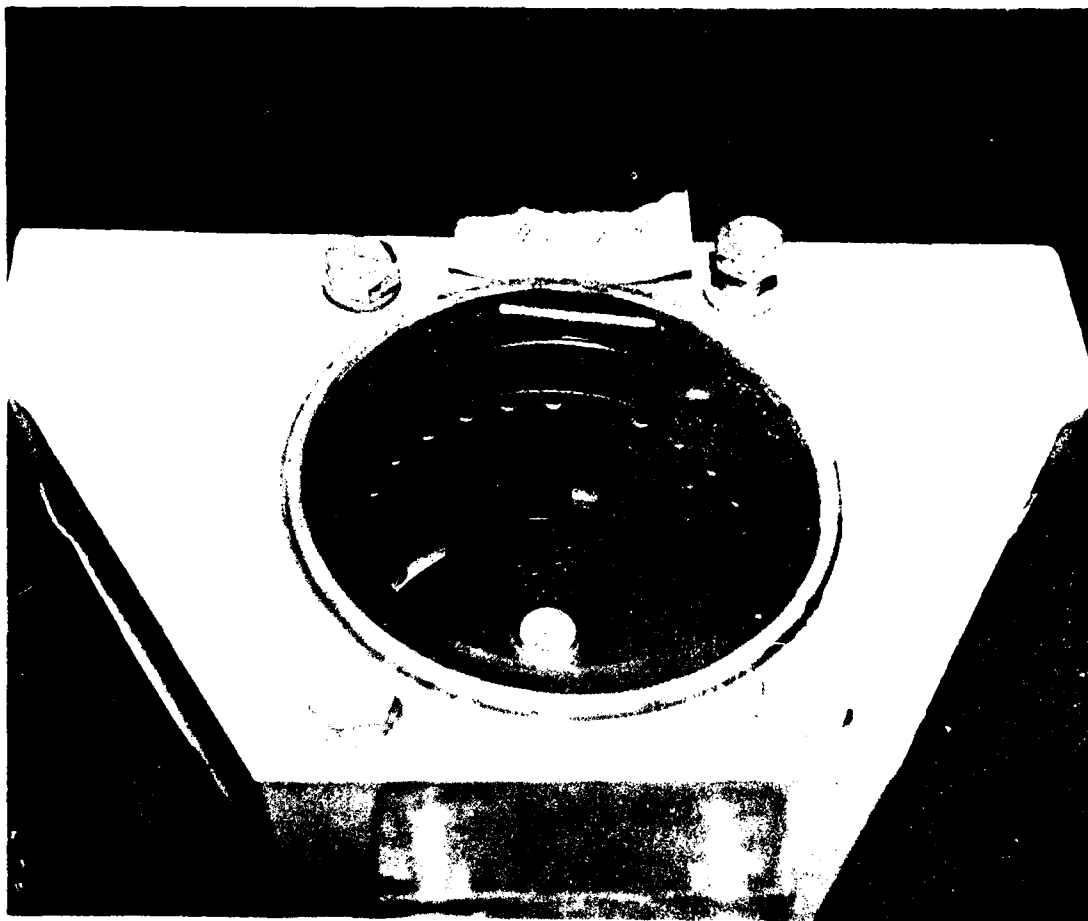
e. S/N A2-705. This hub had operated 1098.1 hours in RVN. The hub was unserviceable for testing because of trunnion bearing deterioration. Inspection revealed that one of the trunnion spindles was badly scored and galled, and the mating roller bearing had one roller missing from the cage and two rollers with approximately 0.250 inch missing (figure 4).

Figure 4. Damaged trunnion bearing rollers.  
(Main-rotor hub, S/N A2-705, 1098.1 operating  
hours.)

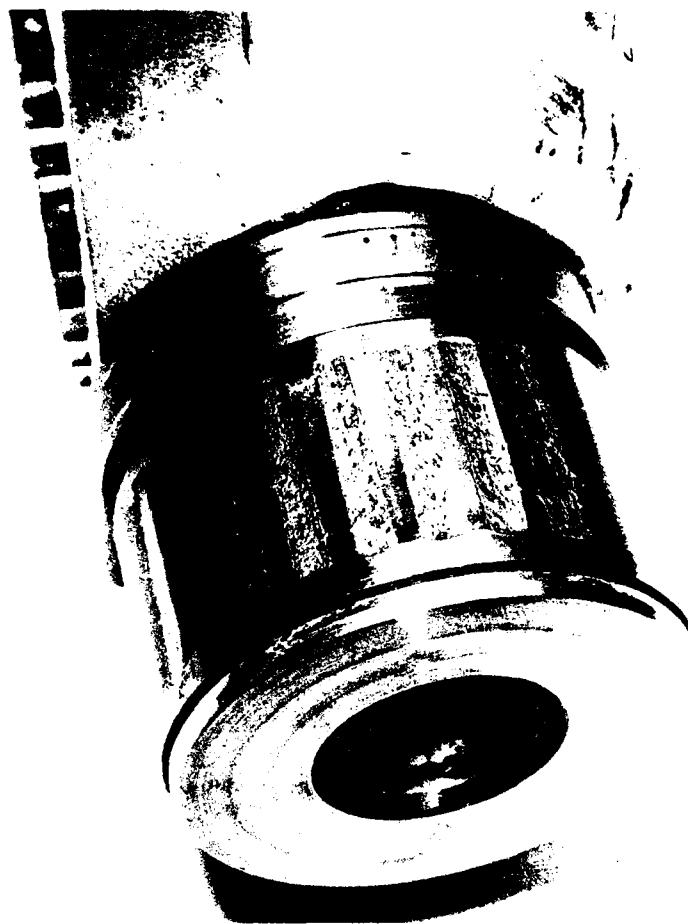
h. S/N A2-361. This hub had operated 866.0 hours in RVN. Inspection revealed this hub to be unserviceable because of trunnion bearing deterioration. Both trunnion spindles were badly galled and scored (figures 8 and 9), and several roller bearings were broken in both bearing housings (figure 10).

Figure 8. Galled trunnion bearing inner race.  
(Main-rotor hub, S/N A2-361, 866.0 operating  
hours.)

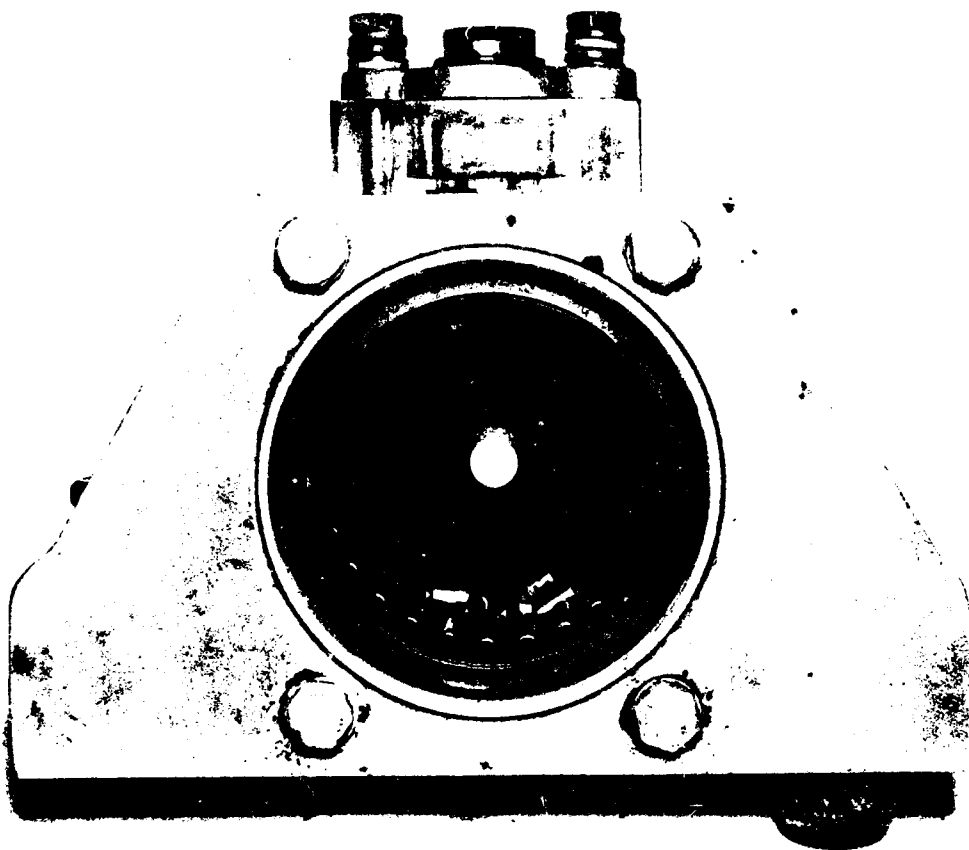
Figure 10. Broken roller bearings.  
(Main-rotor hub, S/N A2-361, 865.0  
operating hours.)

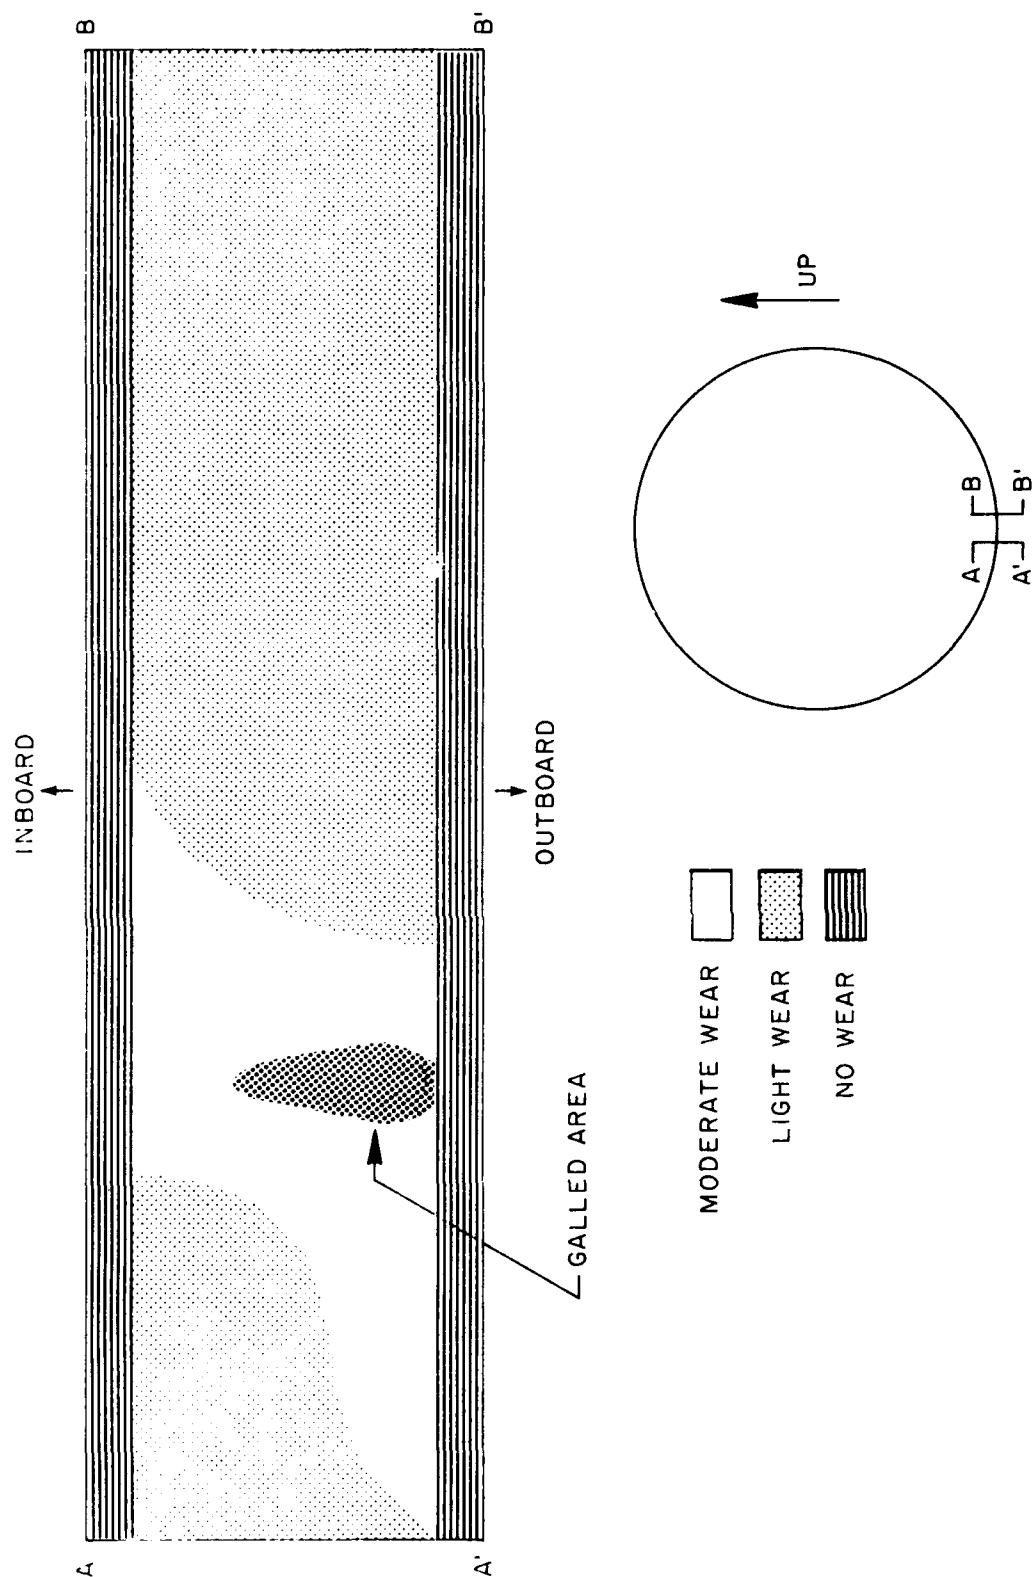
Figure 12.

i. S/N A2-858. In addition to the above-mentioned hubs that were tested or received for testing in the TBO extension program, another hub, S/N A2-858, was inspected as typical of a low-operating-time hub. This hub had previously operated 324.4 hours at Fort Benning, Georgia, on a UH-1B and had been turned in to Atlanta General Depot as serviceable. The operating time at the USAAVNTBD was 207.9 hours for a total operating time of 532.3 hours. Inspection revealed that one trunnion spindle was galled (figure 11). The gall mark was located in the center of the maximum wear area on the inner race of the spindle (figure 12).

j. Discussion. Two factors might have contributed to deterioration of the hub trunnion bearings. One factor may be that the trunnion bearings are overloaded, leading to a failure of the inner race bearing surface. This would be supported by the early deterioration

AREA OF GALLING ON MAIN ROTOR HUB S/N A2-858

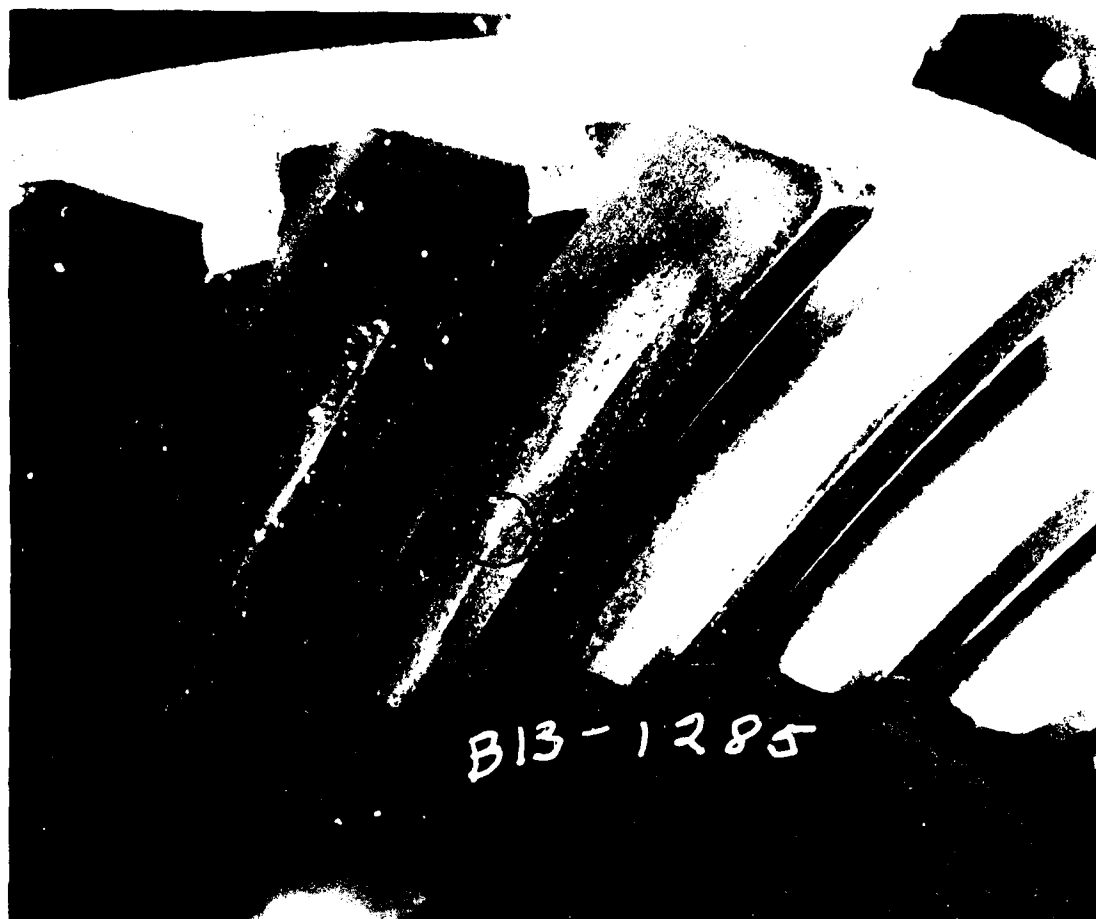
(1) The tail-rotor gearboxes were found to be unserviceable after various operating hours beyond the normal 1100-hour TBO due to pitting on the convex side of the output gear teeth. (See inclosure 1.)

Figure 59. Crack or pit on convex side of output gear tooth (90-degree gearbox, S/N B13-1285, 1300.8 operating hours).

(3) The output gears either be retired at overhaul or be  
refurbished to blend out the wear-pattern overlap area until such time  
that results of additional testing are available.

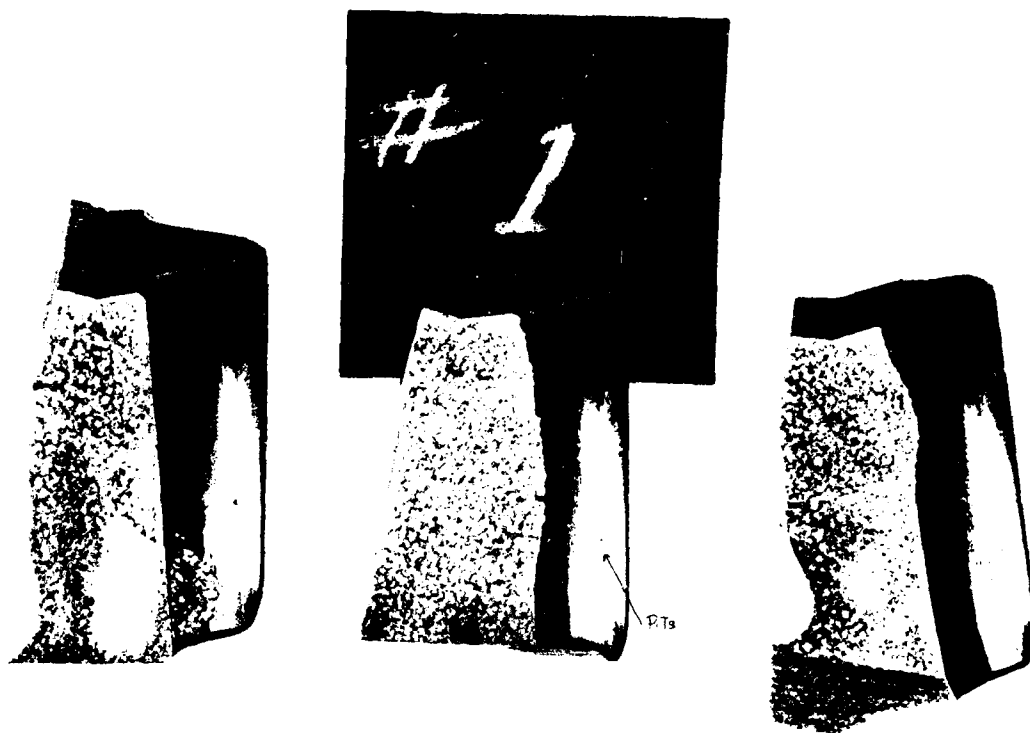
Figure 60. Sectioned output gear teeth showing crack or pits on convex side (90-degree gearbox, S/N B13-1285, 1300.8 operating hours).

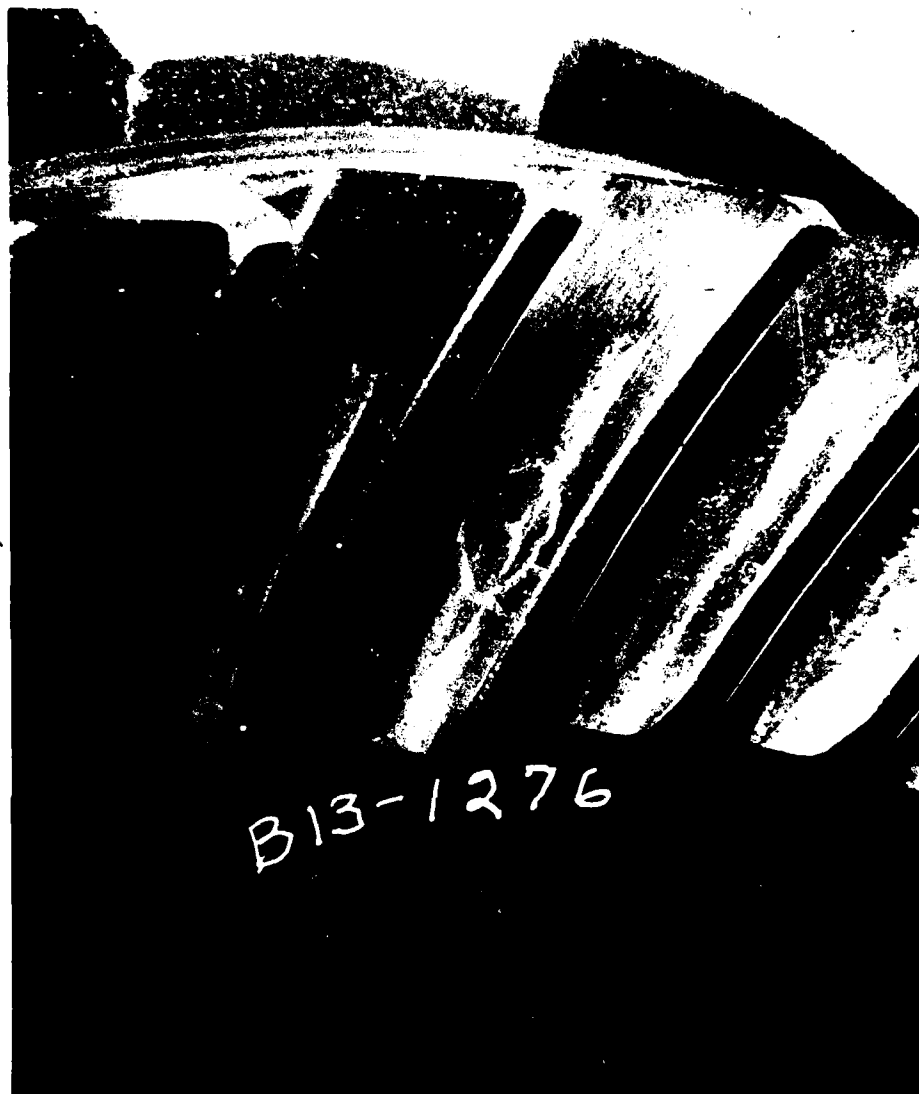
Figure 83. Pitting on convex side of output gear tooth (90-degree gearbox, S/N B13-1276, 1107.0 operating hours).
